***Federal Railroad Administration  
Office of Railroad Safety  
Accident and Analysis Branch***

***Accident Investigation Report  
HQ-2019-1358***

***CSX Transportation (CSX) Side-Collision  
Carey, Ohio  
August 12, 2019***

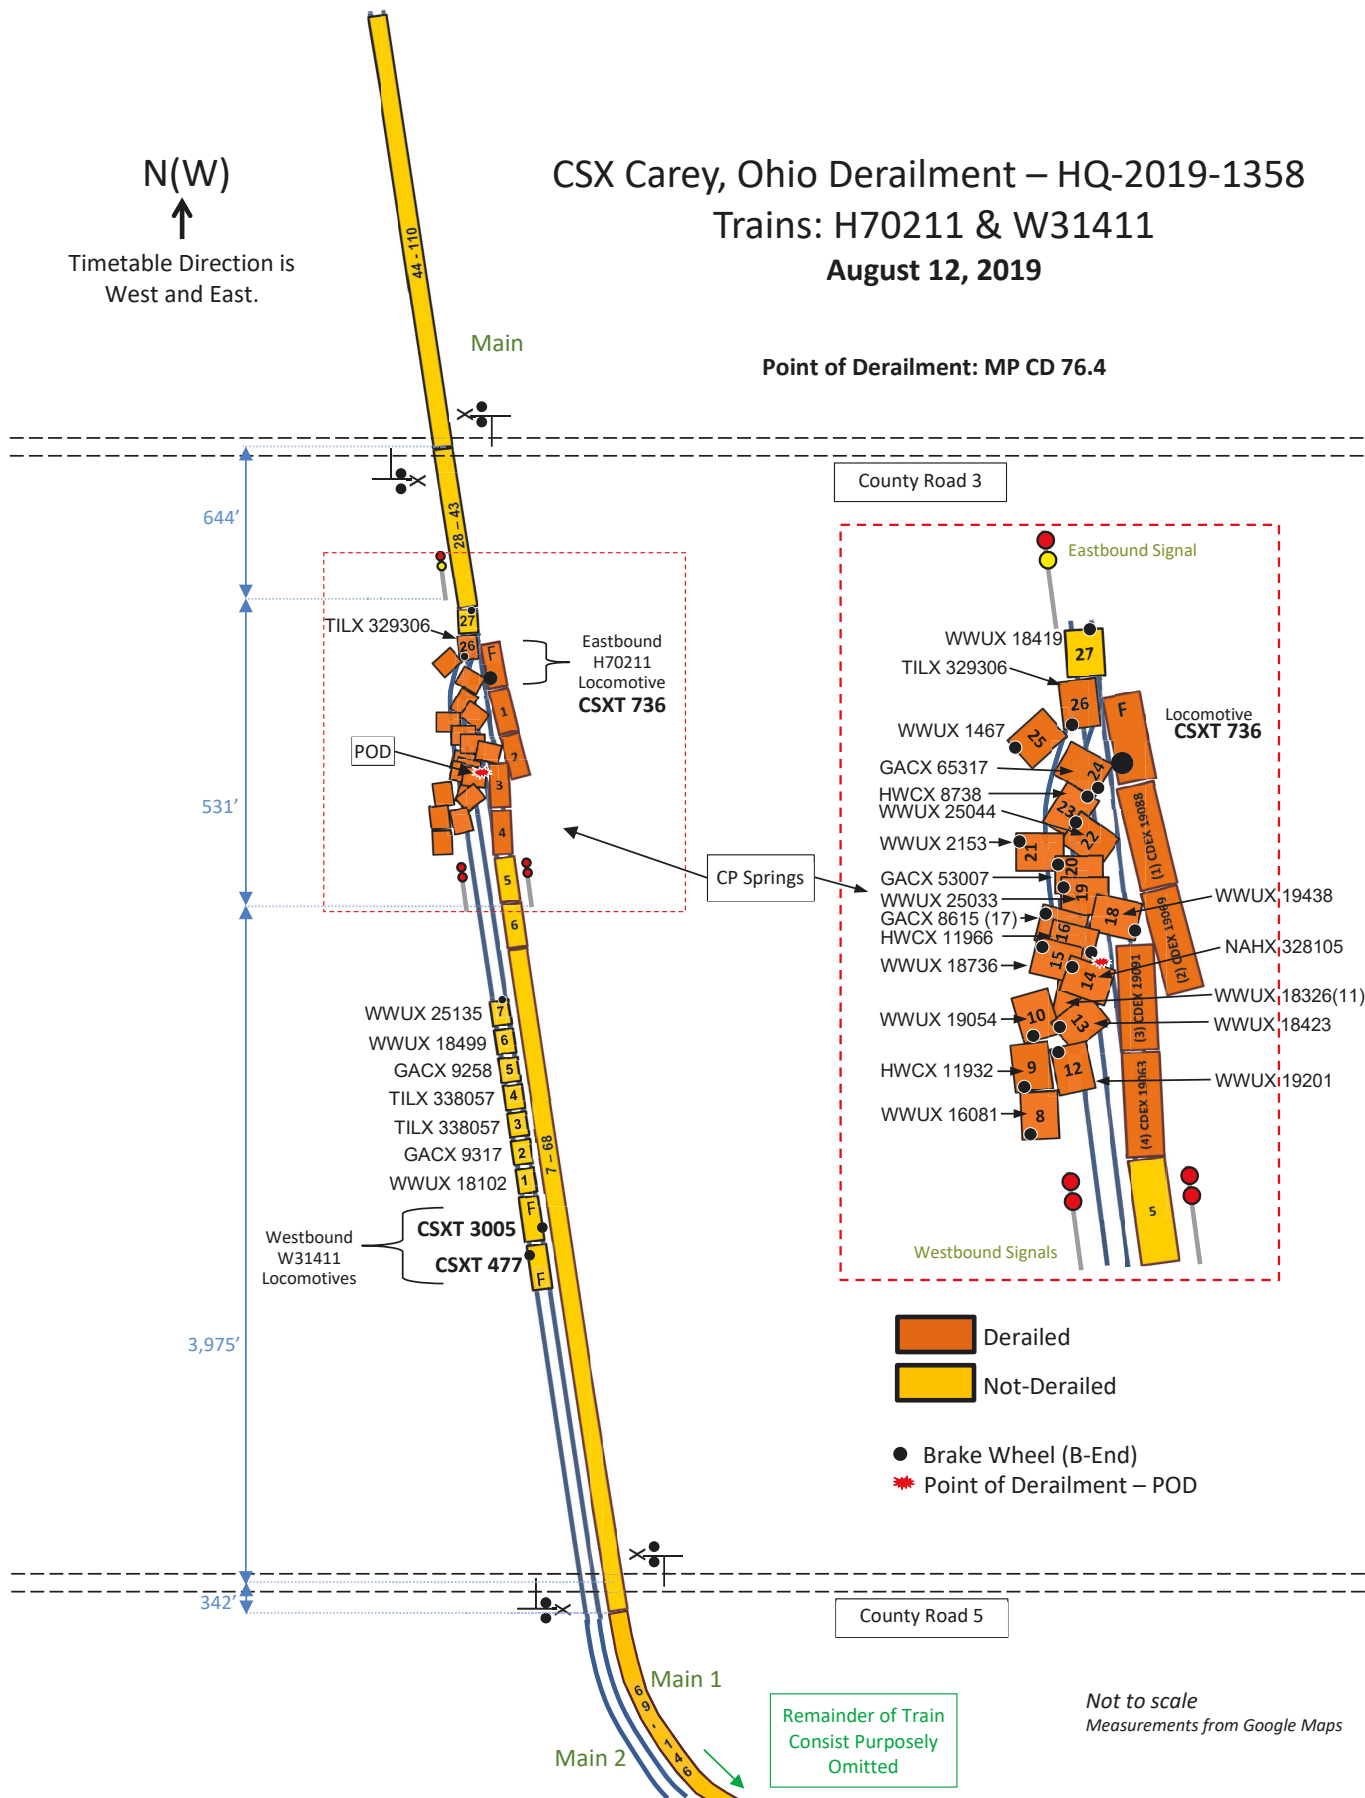
Sketch - Sketch

On August 12, 2019, at approximately 5:08 a.m., EDT, CSX Transportation (CSX) Train H70211 (Train 1) struck CSX Train W31411 (Train 2) at Milepost (MP) CD 76.4, approximately 3.5 miles north of Carey, Ohio. The side collision resulted in the derailment of 1 locomotive and 4 cars of Train 1 and 19 cars on Train 2.

The collision resulted in the lead locomotive (CSXT 736) and lead four cars of Train 1 derailing. The locomotive and lead two cars overturned on their right sides; the third car derailed upright while leaning at a 45-degree angle; and the fourth car derailed the leading set of trucks. Nineteen cars derailed on the struck Train 2 in an accordion-formation, beginning with the eighth car back from the head end. The sixth and seventh cars in the train were struck and damaged; however, they did not derail.
